Yutu Update

Posted by [Phil Stooke](#)

2014/04/10 03:08 CDT

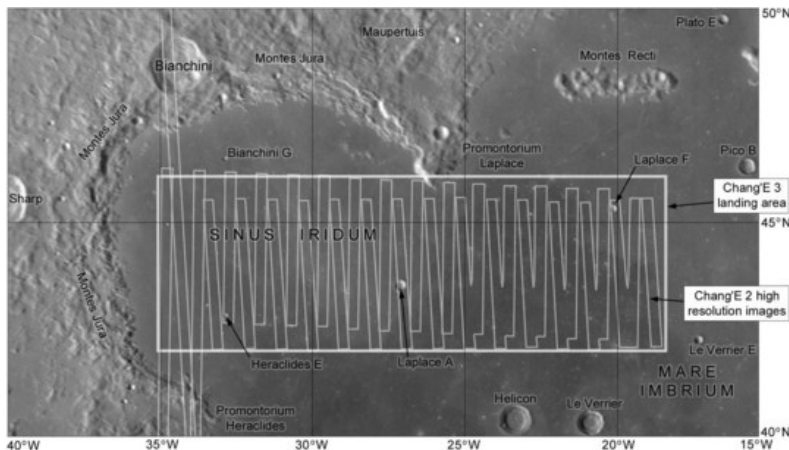
[Chang'e 2 high-resolution image coverage of Chang'e 3 landing area in Sinus Iridum](#)

This map shows the extent of the Chang'e 3 landing region, extending outside Sinus Iridum as well as inside it, and the areas where Chang'e 2 achieved imaging coverage at about 1.5 meters per pixel.

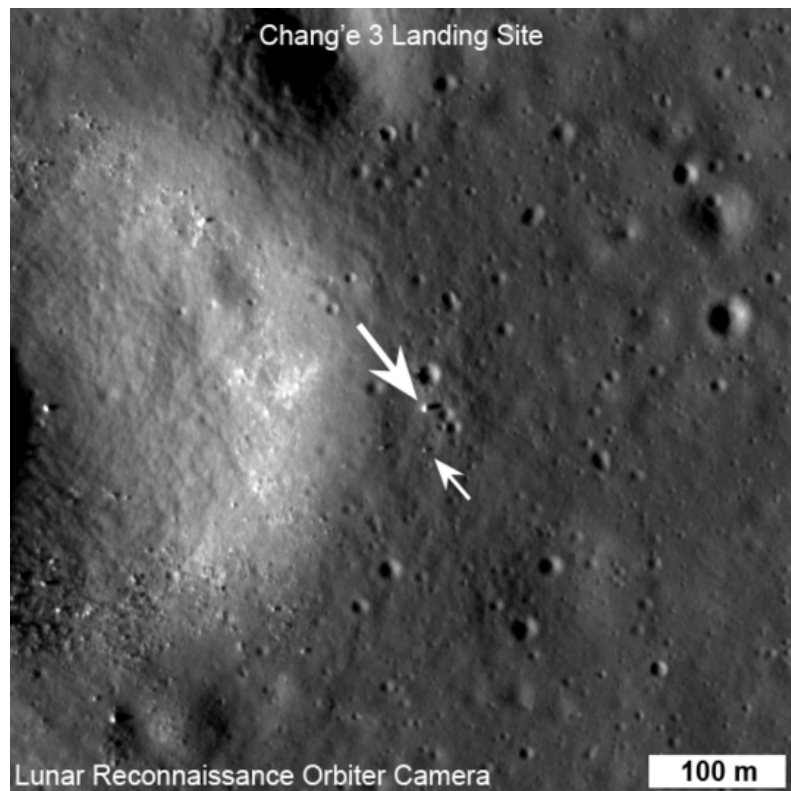
Chang'e 3 and Yutu seen from orbit

On December 25, 2013, Lunar Reconnaissance Orbiter spied Chang'e 3 and Yutu on the lunar surface. It was near sunset on the pair's first lunar day of operations. In its extended mission, Lunar Reconnaissance Orbiter is in an elliptical orbit whose altitude over the Chang'e 3 landing site is 150 kilometers, so its highest-resolution images have about 1.5 meters per pixel.

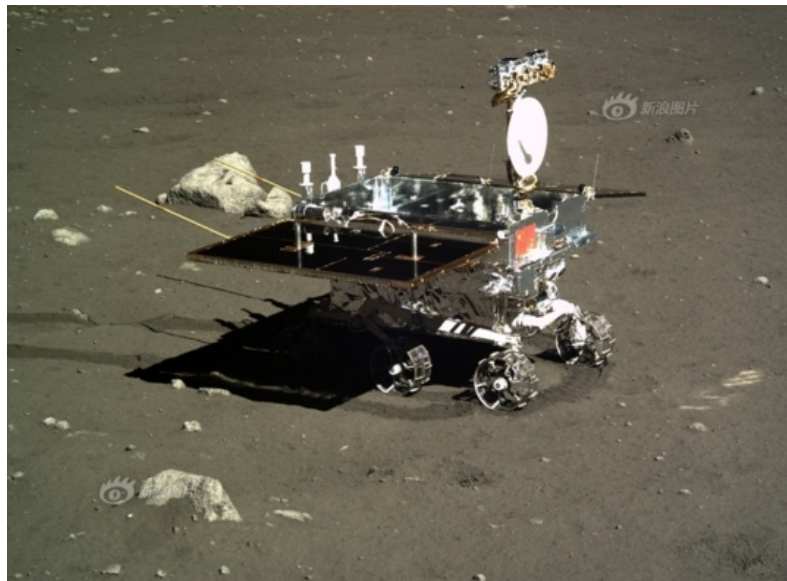
Yutu on the Moon, December 16, 2013

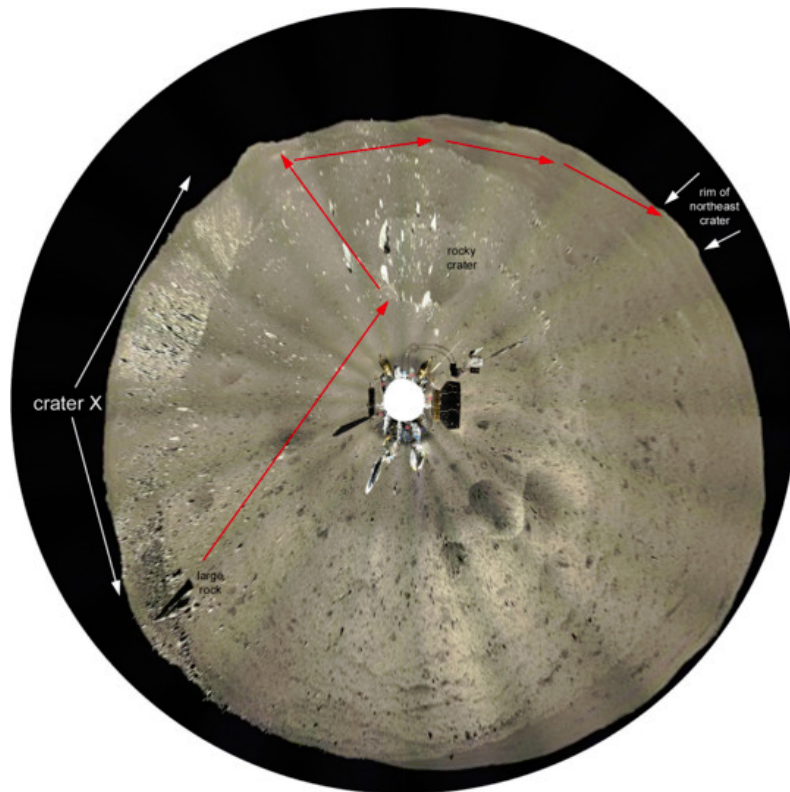
Yutu's planned future route

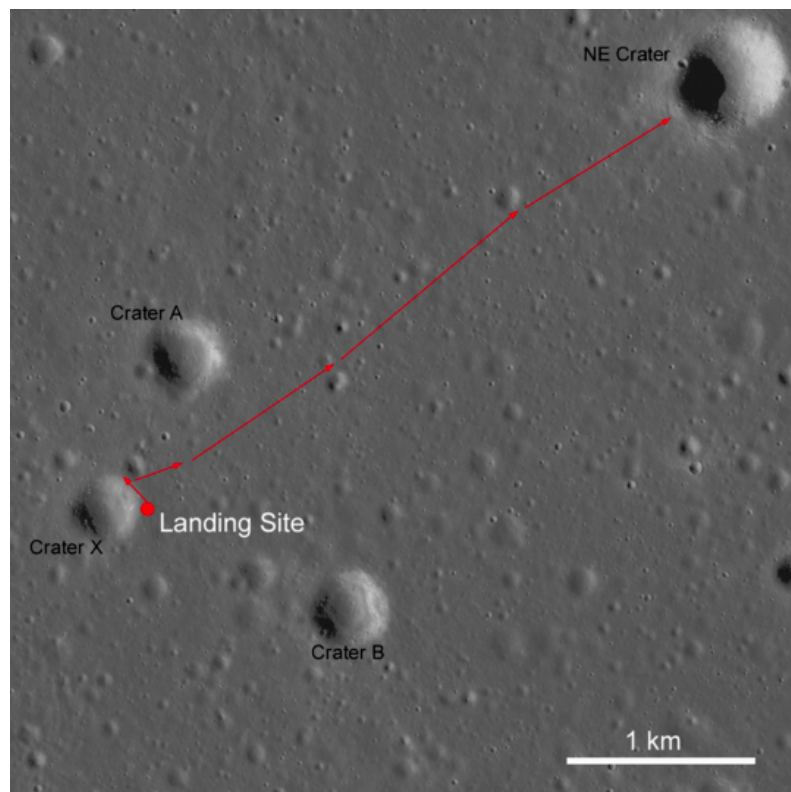
Yutu's planned future targets

Had Yutu not lost its mobility, this is what its future path may have looked like.
